Town of Granby, Connecticut

2020 Annual Report_DRAFT

**General Permit for the Discharge of Stormwater
from Small Municipal Separate Storm Sewer Systems**

Permit Number GSM000029

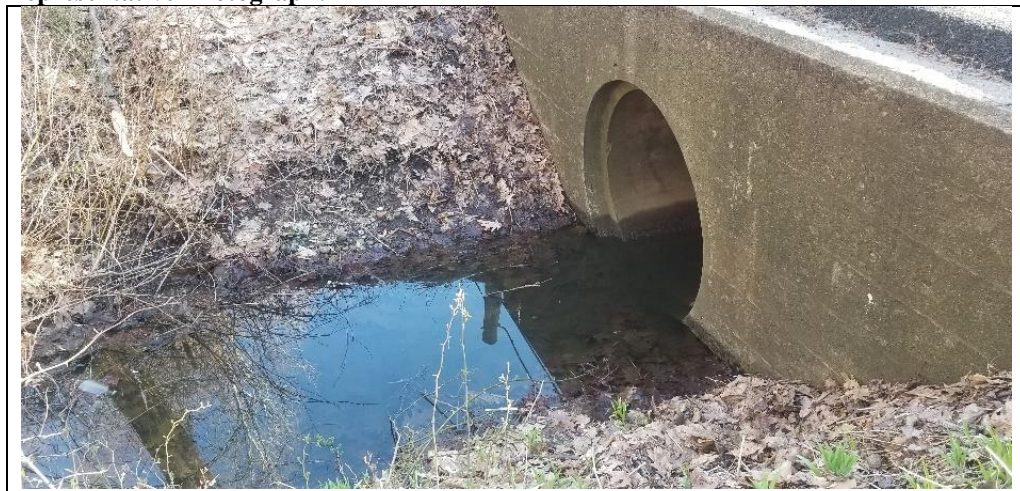
Outfall Details (piping material/diameter, structural condition, erosion, trash present, sediment, etc.): Overall good condition

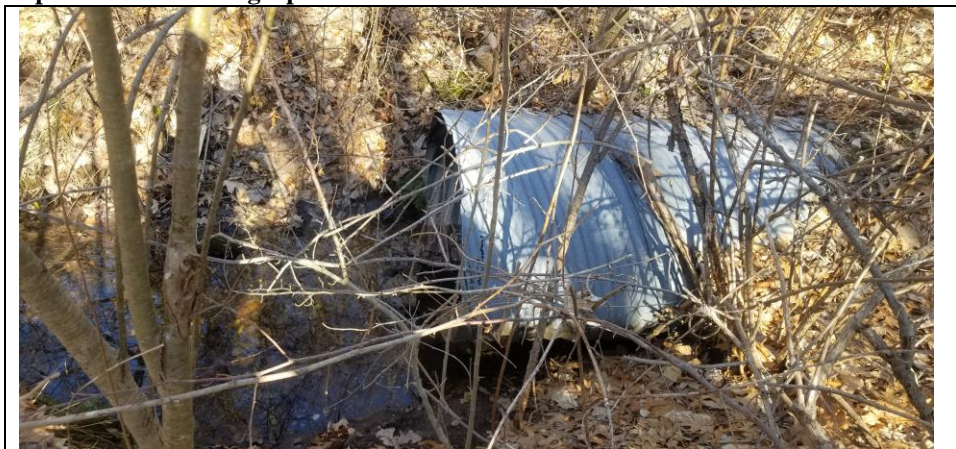
Outfall ID: OF-14

Outfall Details (piping material/diameter, structural condition, erosion, trash present, sediment, etc.): 48" corrugated metal pipe, minor damage – still suitable for sampling, leaf litter in outfall

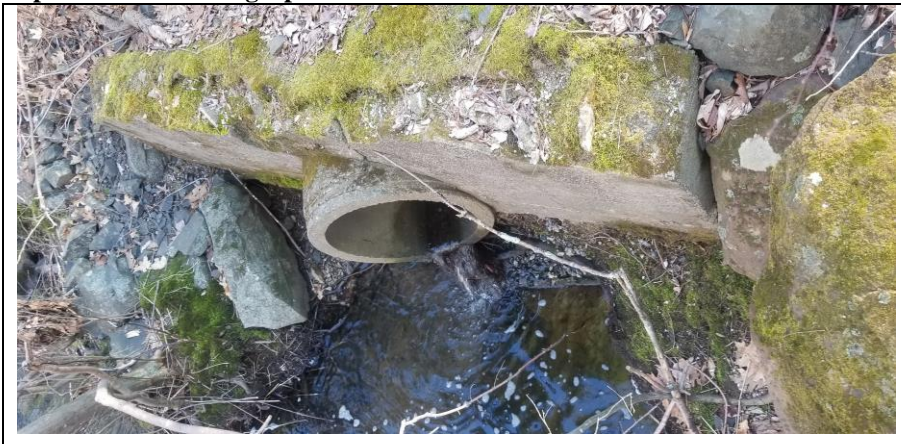
Outfall ID: OF-15

Outfall Details (piping material/diameter, structural condition, erosion, trash present, sediment, etc.): 24" concrete channel discharging directly into Salmon Brook, overall good condition, mild erosion observed

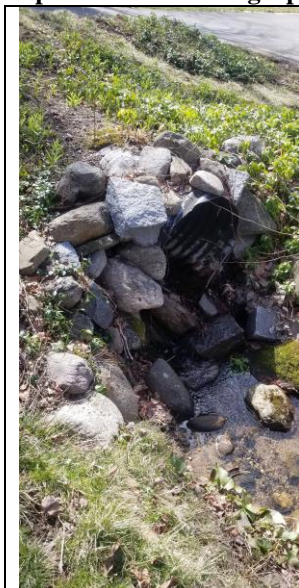
Outfall ID: OF-44

Outfall Details (piping material/diameter, structural condition, erosion, trash present, sediment, etc.): 24" pipe diameter, overall good condition, discharging directly into surface water

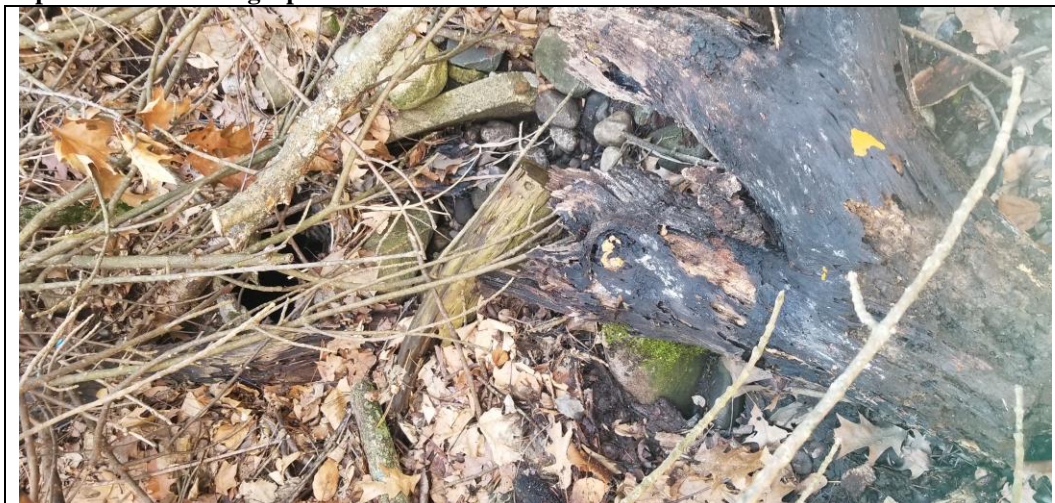
Outfall ID: OF-73

Outfall Details (piping material/diameter, structural condition, erosion, trash present, sediment, etc.): Behind landscaped residential homes, significant erosion observed, outfall silted in

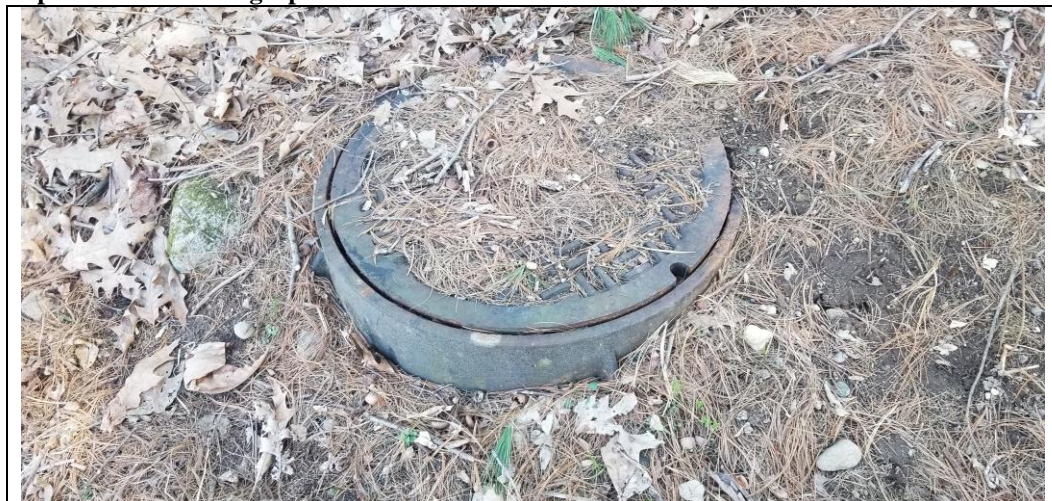
Outfall ID: OF-74

Outfall Details (piping material/diameter, structural condition, erosion, trash present, sediment, etc.): Stormwater manhole, no discharge, overall good condition

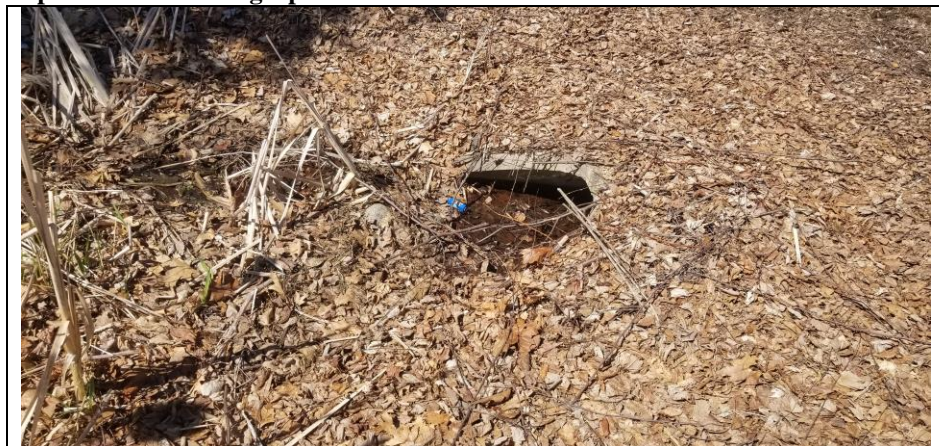
Outfall ID: OF-86

Outfall Details (piping material/diameter, structural condition, erosion, trash present, sediment, etc.): Discharges to retention pond, leaf litter in outfall

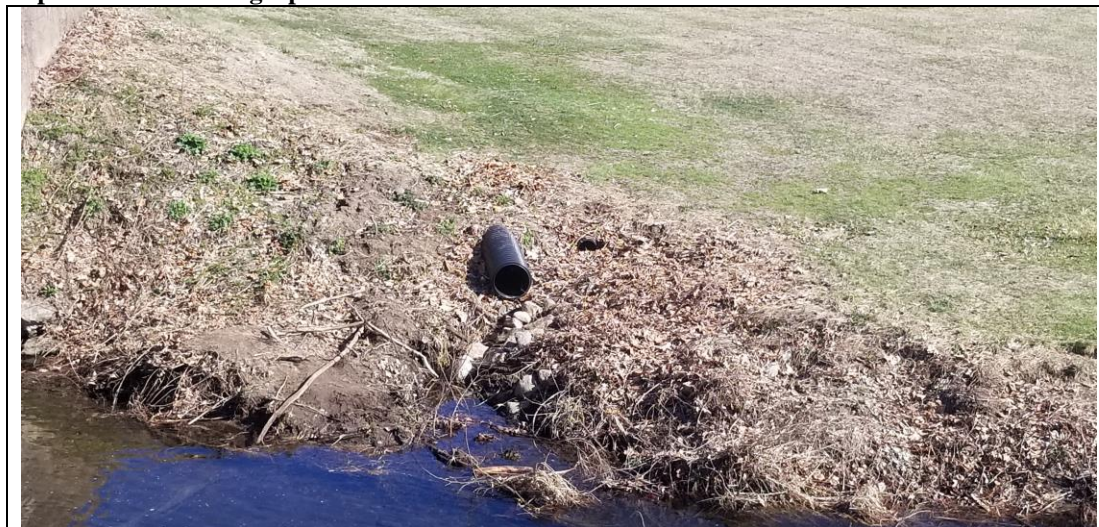
Outfall ID: OF-102

Outfall Details (piping material/diameter, structural condition, erosion, trash present, sediment, etc.): 24" diameter pipe, overall good condition

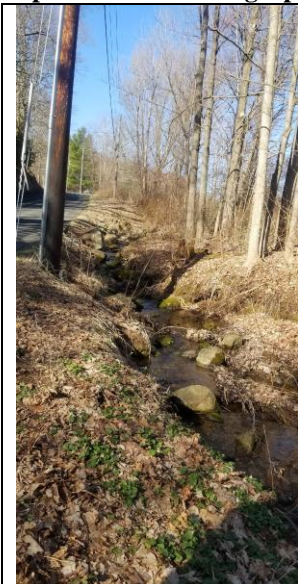
Outfall ID: OF-103 (stream)

Outfall Details (piping material/diameter, structural condition, erosion, trash present, sediment, etc.): Minor erosion observed

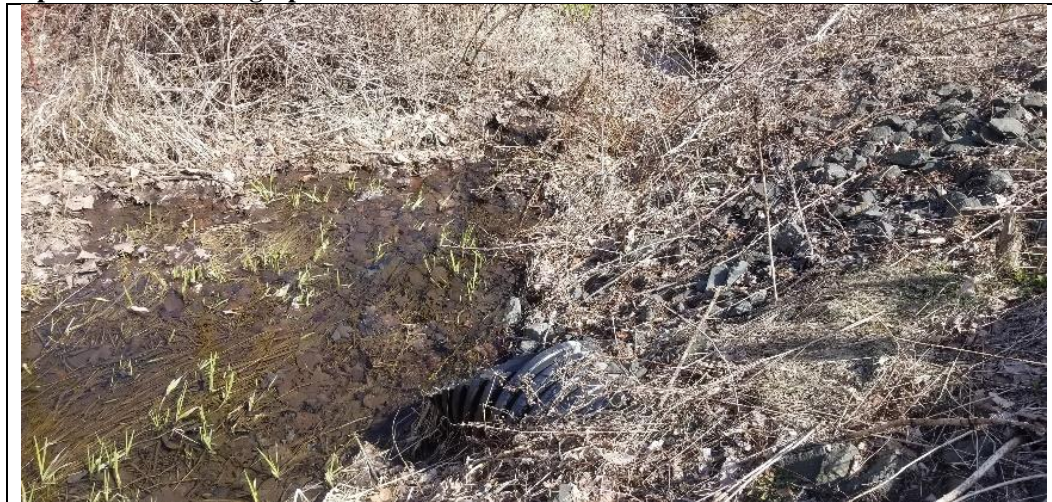
Outfall ID: OF-103

Outfall Details (piping material/diameter, structural condition, erosion, trash present, sediment, etc.): Overall good condition, discharges directly into surface water body

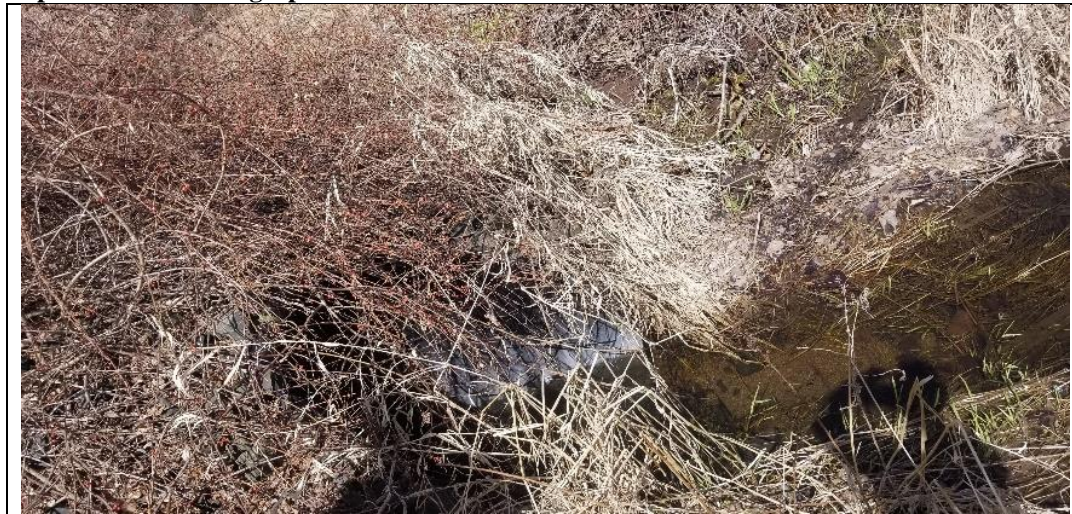
Outfall ID: OF-104

Outfall Details (piping material/diameter, structural condition, erosion, trash present, sediment, etc.): Overall good condition, discharges directly into surface water body, overgrown around outlet pipe

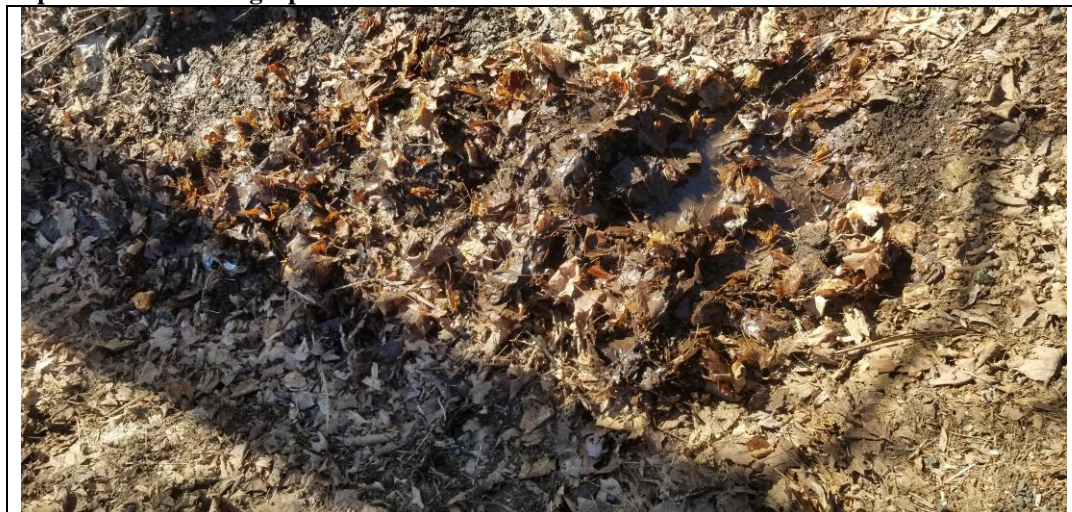
Outfall ID: OF-105

Outfall Details (piping material/diameter, structural condition, erosion, trash present, sediment, etc.): Outfall silted in, significant leaf litter in outfall, pipe potentially damaged

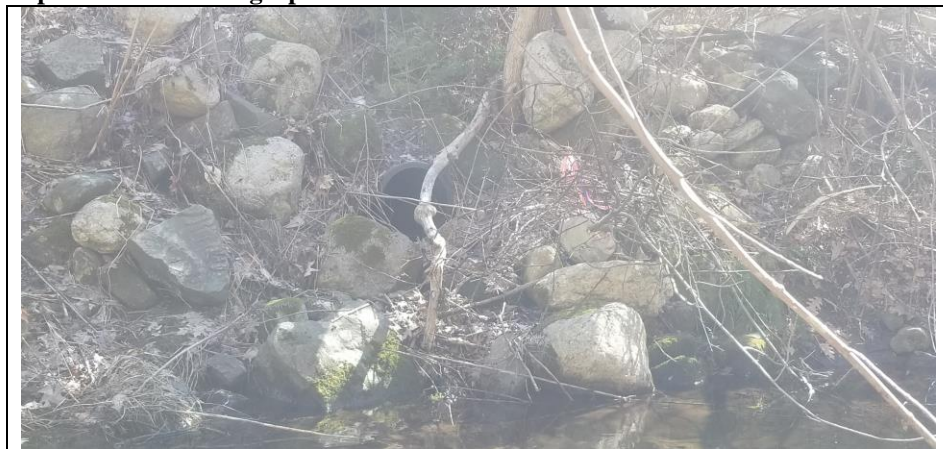
Outfall ID: OF-109

Outfall Details (piping material/diameter, structural condition, erosion, trash present, sediment, etc.): Discharges into rip rap, 12-16" diameter, overall good condition

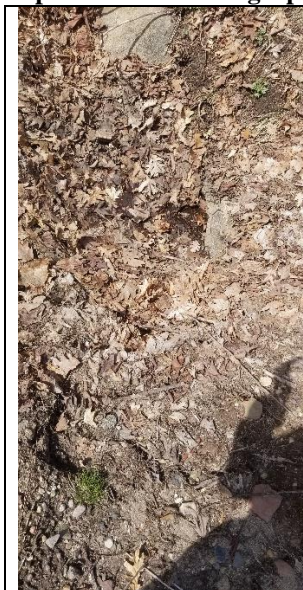
Outfall ID: OF-152

Outfall Details (piping material/diameter, structural condition, erosion, trash present, sediment, etc.): Outfall clogged with leaves

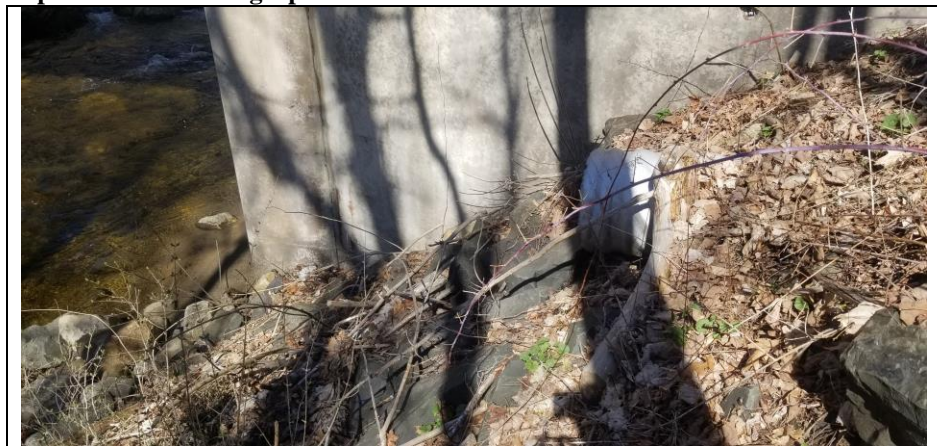
Outfall ID: OF-153

Outfall Details (piping material/diameter, structural condition, erosion, trash present, sediment, etc.): 12-16" diameter, approximately 10' from road, discharging into rip rap for erosion control, overall good condition

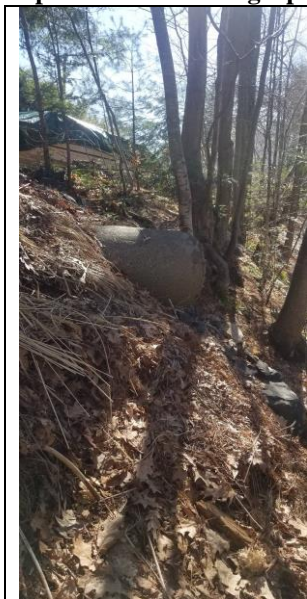
Outfall ID: OF-154

Outfall Details (piping material/diameter, structural condition, erosion, trash present, sediment, etc.): 24" pipe, overall good condition

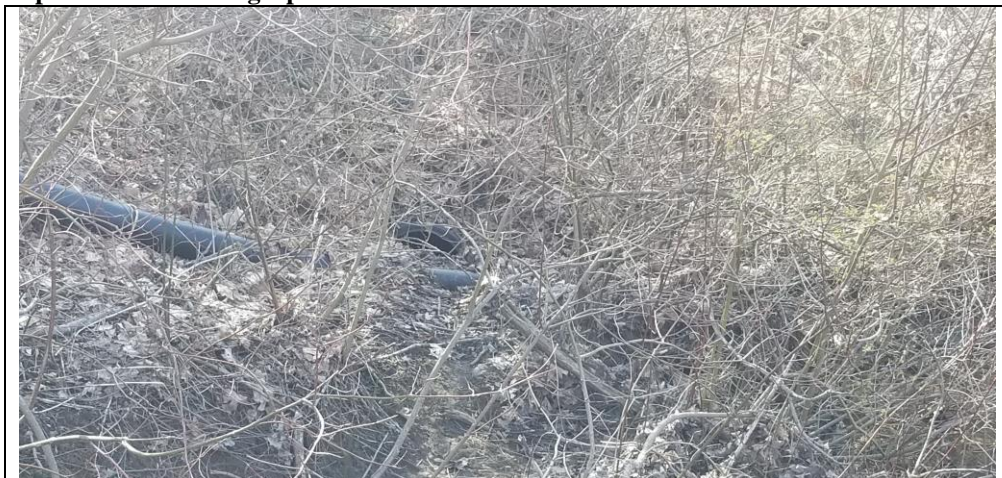
Outfall ID: OF-155

Outfall Details (piping material/diameter, structural condition, erosion, trash present, sediment, etc.): Outfall is silted in, 12-16" diameter pipe, adjacent to bridge
